CONSERVATION AND REFUNCTIONING OF A TRADITIONAL HOUSE IN THE VILLAGE OF MUSTAFAPAŞA (SINASOS) IN THE CAPPADOCIA REGION ¹

Ceyda ÇİFTÇİ¹, Özlem KÖPRÜLÜ BAĞBANCI²

Doi: 10.17365/TMD.2018.1.1

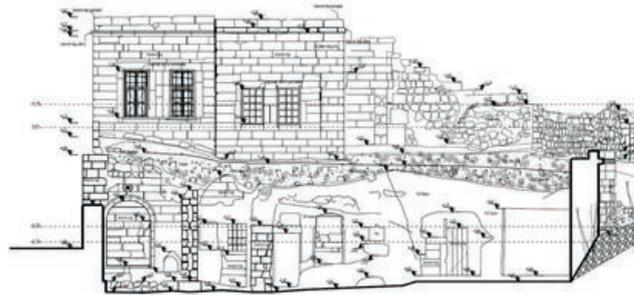
Figure 4. Section C-C

On the western wall of the room, there is a window with a fireplace and a niche, and on the northern wall, there is an arch and the window of room Z02. On the eastern wall, there

is an entryway and a niche. It is concluded that the room Z01 was later added as vaulted summer kitchen (Fig.4), (Photo 4).

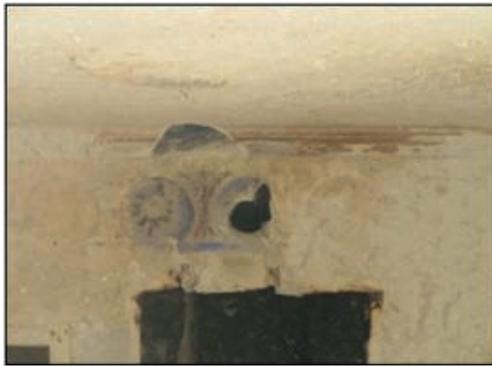
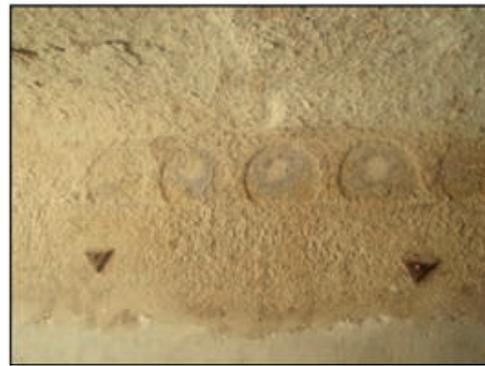
The entrance to room Z11 has been destroyed. There is a fireplace that was demolished on the north wall. There is a small niche to the east and a larger niche to the west of the fireplace. There is a window on the western wall that connects to room Z10 and a door on the western wall that allows passage into this room. There is a 16 cm high ignimbrite rock terrace that extends along the northern and western walls. Room Z11 measures 5.73x2.88 m. and is 2.43 m in height. The walls of the room, the floor covering and the ceiling are made of ignimbrite rock. In addition, there are ornamentations made with ocher on the ignimbrite rock walls (Photos 7, 8).

Photos 7, 8. The Ornamentations on the North Wall of Room Z11

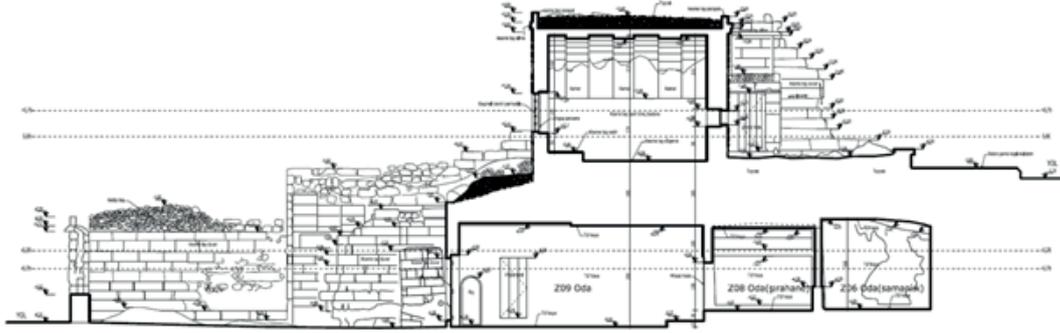
Figure 7. Section B-B

courtyard, there is a room with a collapsed arch. Given the general situation of the structure, it was observed that while the ignimbrite rock areas in the lower courtyard were preserved, all of the rubble stone-walled areas were destroyed and the rooms constructed of cut stone with arched and wooden ceilings were partially or totally destroyed (Fig.7).

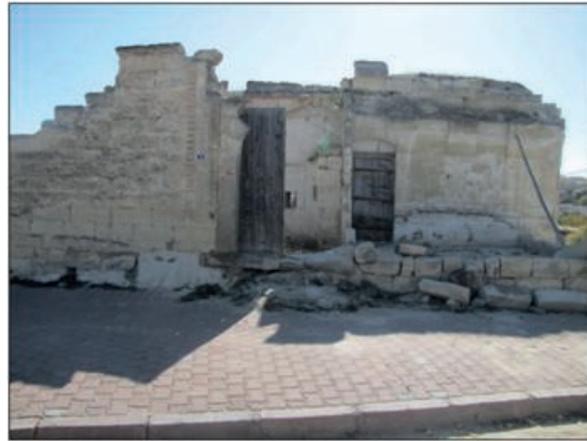
On the north side of the building, stones that supported the arch are in ruins today. Although part of the courtyard's entrance door is intact,

most of it has collapsed. The courtyard wall on this facade is made entirely of cut stone (Photo 11).

Photo 11. Upper Elevation Courtyard and North Facade of the Building

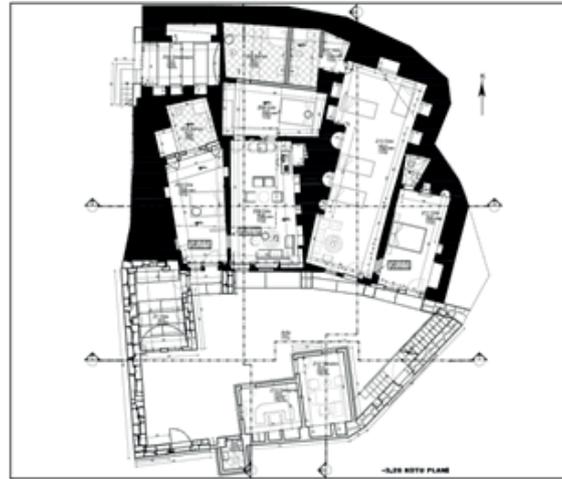
Figure 11. The Adaptive Re-Use Project of -3.26 Elevation

been whitewashed with lime and the dirt due to atmospheric conditions on the exterior facades of the stone surfaces will be cleaned by using wire brushes or tooth chisel. On the stone and rock surfaces of the building, there is vegetation; hence, the surfaces have experi-

enced changes in colour caused due to leaking water. Accordingly, it is recommended that the plants and trees that have formed on the walls off the structure be removed in an appropriate way (Fig. 11).
