DETERIORATION ON THE STONE SURFACES OF THE DIYARBAKIR
NEBİ MOSQUE ⁽¹⁾

DİYARBAKIR NEBİ CAMİİ TAŞ YÜZEYLERİNDEKİ BOZUNMALAR

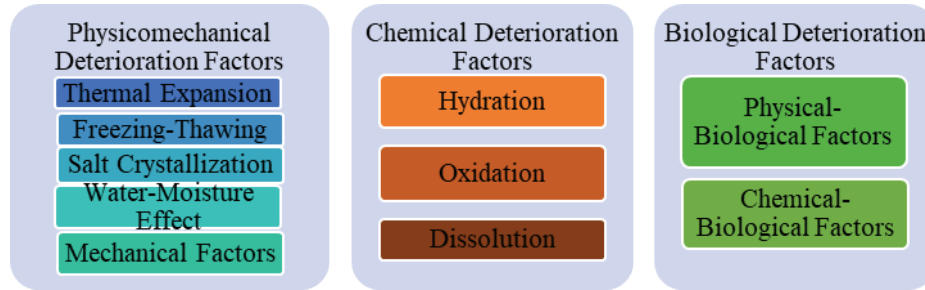
Figure 1. Classification of Factors Causing Deterioration of Stone Monuments (Öcal and Dal, 2012: 27)

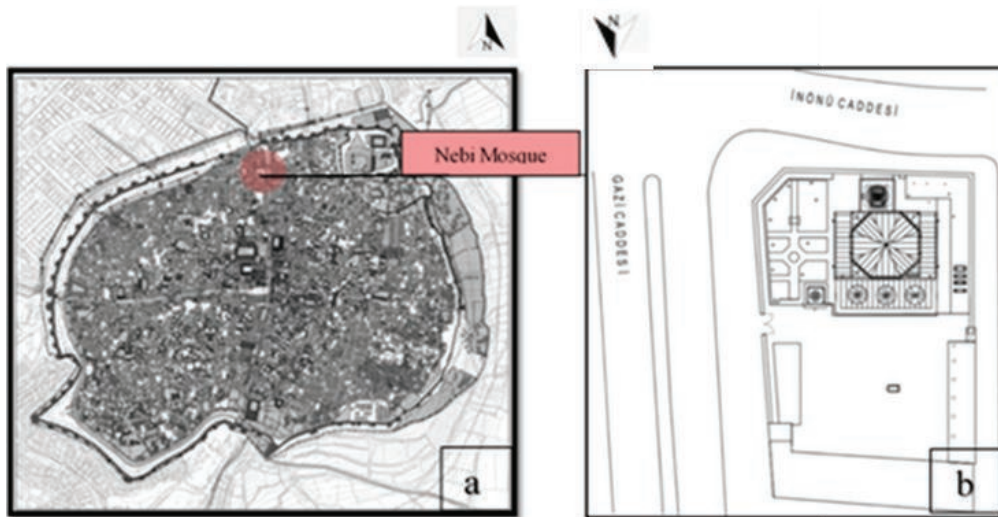
Figure 2a. The Location of the Nebi Mosque in Suriçi' b. Site Plan of the Nebi Mosque (Karaca and Öztürk, 2019: 4)

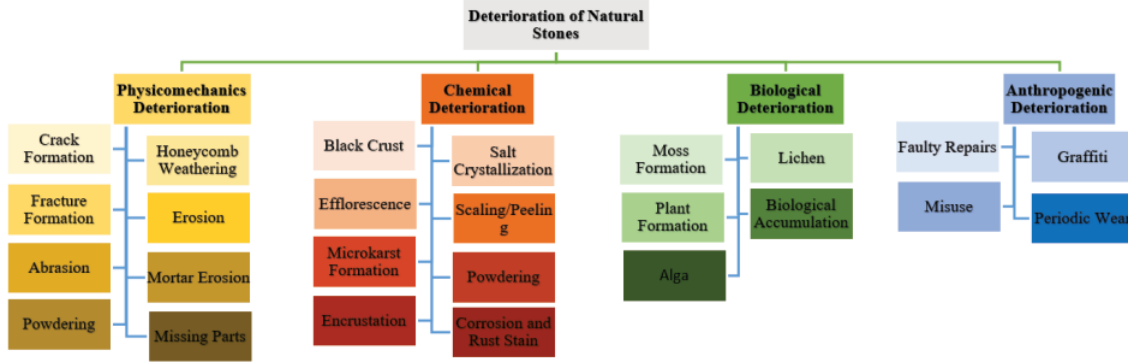
Figure 4. Classification of Deterioration Types Observed in Natural Stones (Hasbay et al., 2018: 2-8; Hasbay and Hattap, 2017: 28-40)

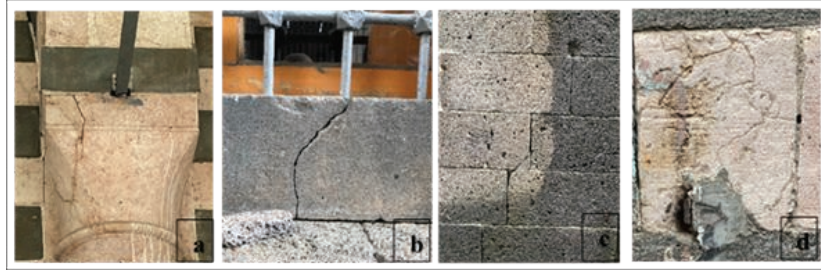
Figure 5. Capillary and Structural Crack Formation a. Corbel on the Arch on the North Façade b. Window on the West Façade c. West Façade Wall d. East Façade Wall

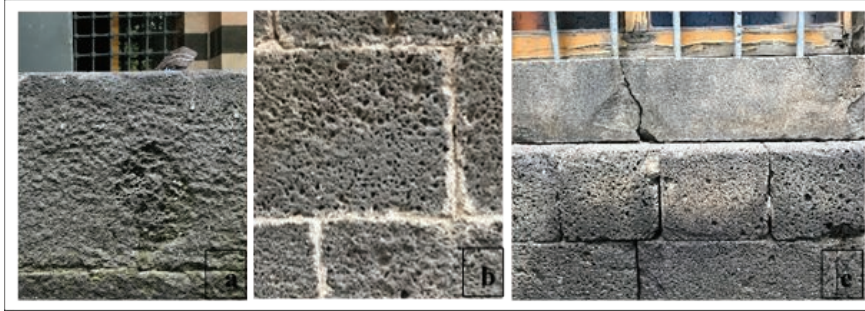
Figure 6. Alveolization a. Raised Floor of the North Façade b. West Façade Wall c. Window on the South Façade

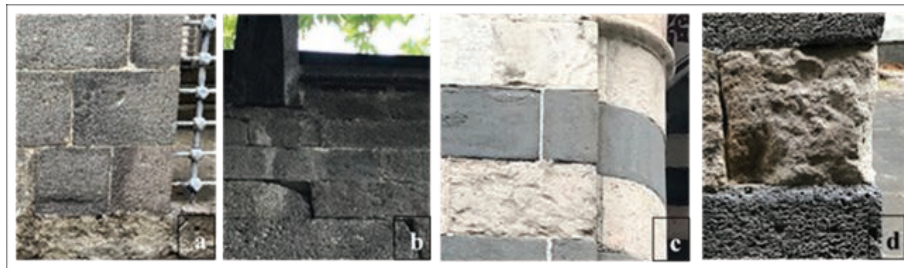
Figure 7. Abrasion / Loss of Surface a. Mausoleum Wall on the East Façade b. West Façade Wall c. North Façade Wall d. Minaret Wall on the West Façade

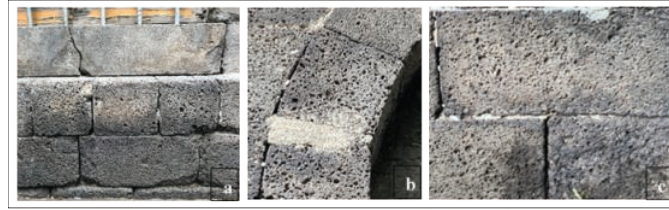
Figure 8. Mortar Erosion a. South Façade Wall b. South Façade Arch c. South Façade Wall

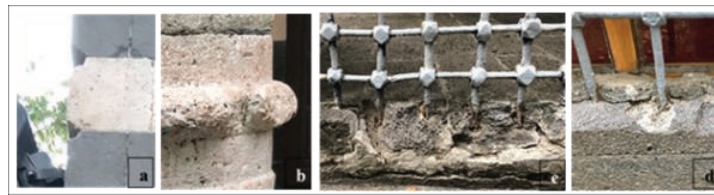
Figure 9. Missing Parts a. North Façade Wall b. Column Bracelet on the North Façade c. Mausoleum Wall on the East Façade d. East Façade Window

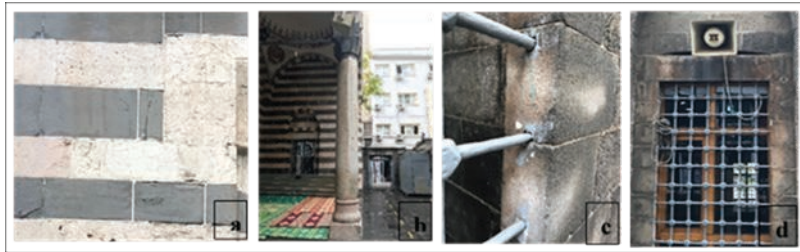
Figure 10. Black Crust a. North Façade Wall b. The column on the North Façade c. West Façade Wall d. Window Lintel on the West Façade

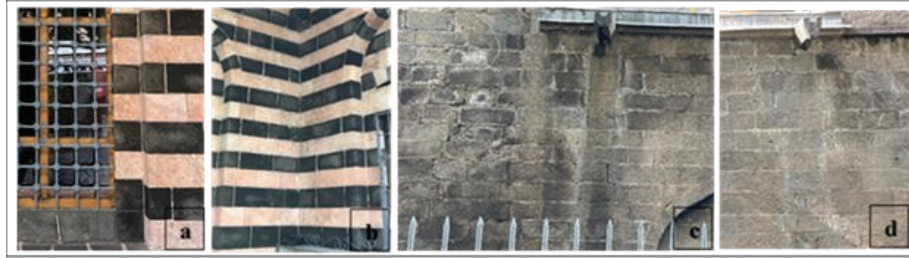
Figure 11. Efflorescence/Salt Crystallization a. North Façade Wall b. North-East Façade Wall c. West Façade Wall d. East Façade Wall

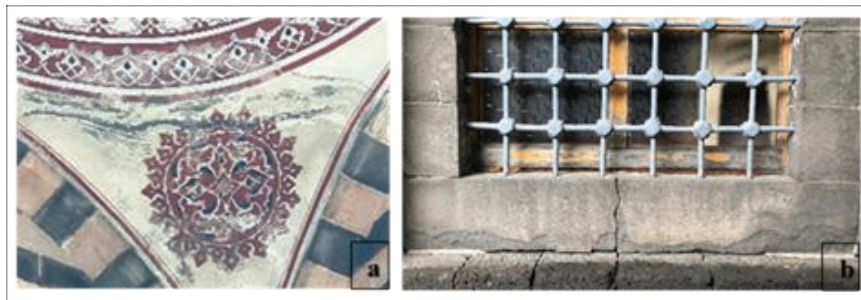
Figure 12. Scaling/Peeling a. Pendant on the North Façade b. Window on the South Façade

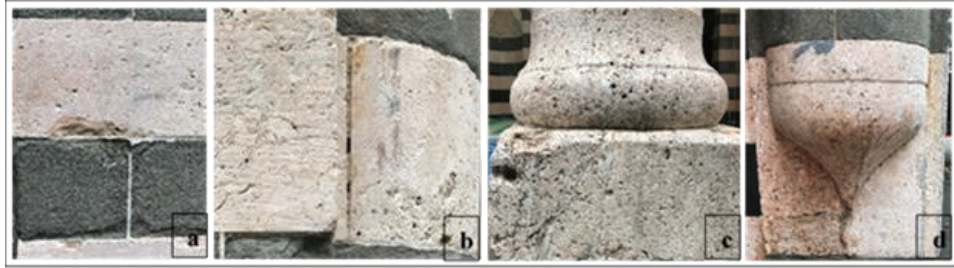
Figure 13. Microkarst Formation a. North Façade Wall b. North Façade Wall c. The column on the North Façade (Left) d. North Façade Wall

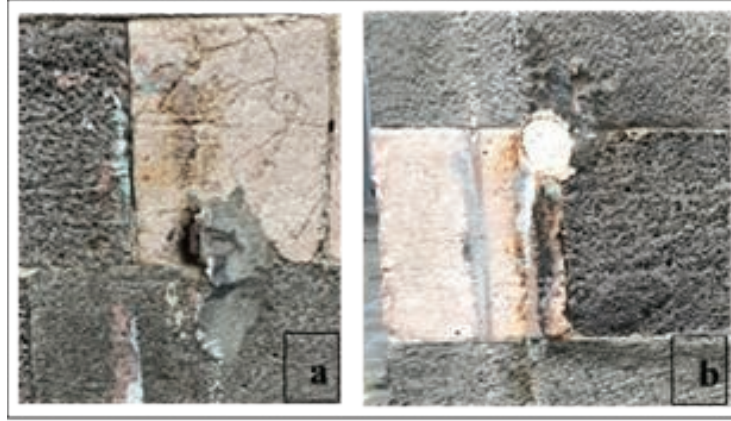
Figure 14. Corrosion and Rust Stain a. East Façade Wall b. West Façade Wall

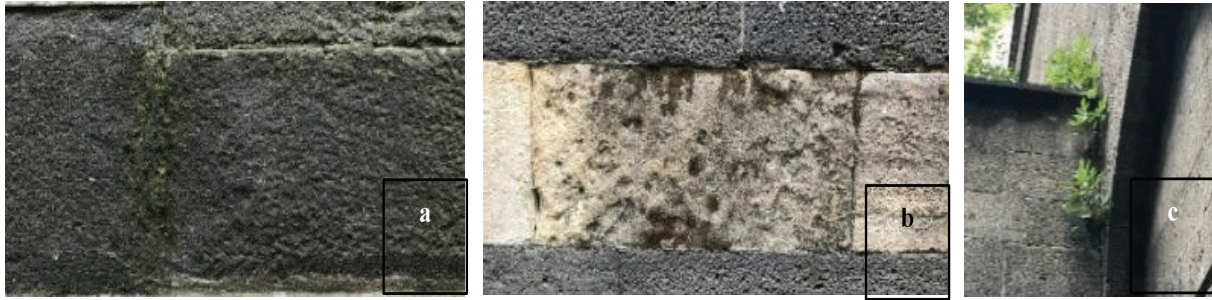
Figure 15 a. Moss Colonization-Raised Floor on the North Façade b. Lichen Colonization-Minaret Wall on the North Façade c. Plant Colonization-Mausoleum Wall on the East Façade

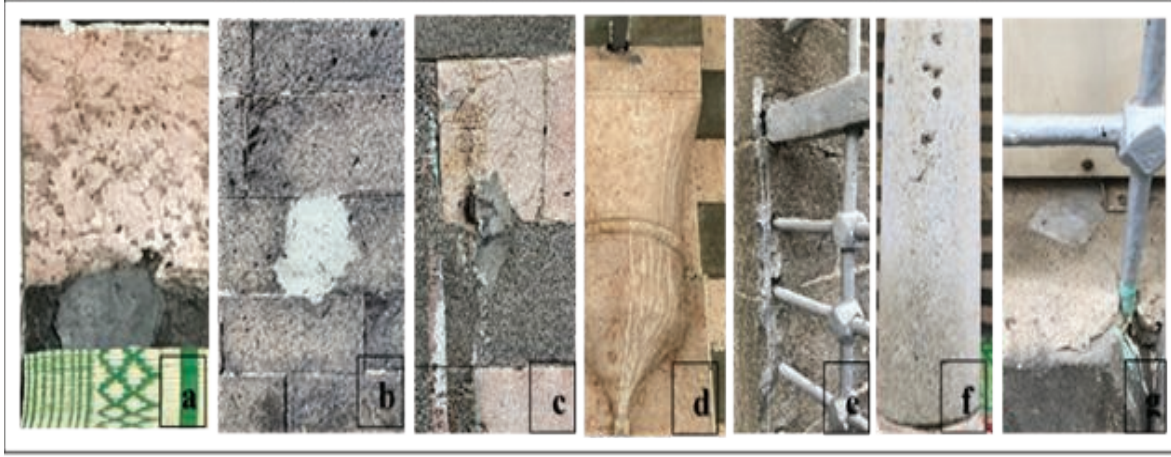
Figure 16. Faulty Repairs a. North Façade Wall b. South Façade Wall c. East Façade Wall d. North Façade Wall e. Mausoleum Wall on the West Façade f. Column on the North Façade g. West Façade Wall

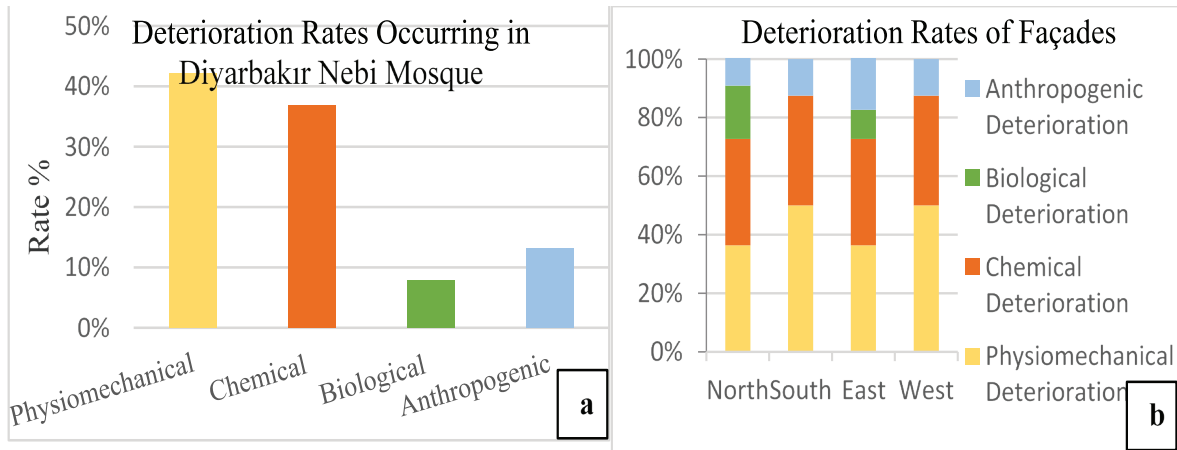
Figure 17a. Graphical Representation of the Deterioration Rates Occurring in Diyarbakır Nebi Mosque b. Graphical Representation of the Distribution of Deterioration Types in Diyarbakır Nebi Mosque by Façades
