CONSERVATION AND REFUNCTIONING OF A TRADITIONAL HOUSE IN THE VILLAGE OF MUSTAFAPAŞA (SINASOS) IN THE CAPPADOCIA REGION ¹

Ceyda ÇİFTÇİ¹, Özlem KÖPRÜLÜ BAĞBANCI²

Doi: 10.17365/TMD.2018.1.1

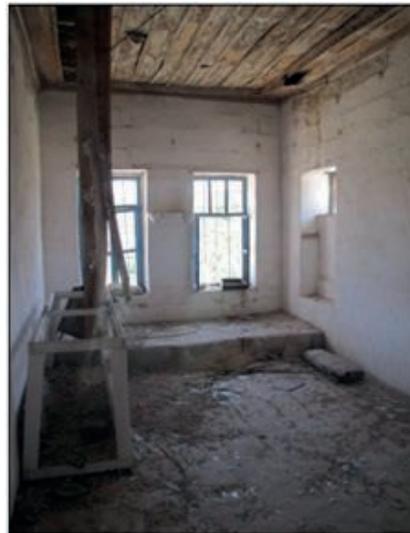
Photo 9. The South Wall of Room 101 and the seki

Room 101 is located on the west side of the rooms in the upper courtyard. Room 101 measures 3.11x6.25 m and is 3.25 m high. The walls of the room were constructed of cut stone. The entrance gate is located on the north end of the east wall, and the room is illuminated through a rectangular window with two wooden wings on the south side (Photo 9). In front of the windows on the

south facade, there is a 27cm tall *seki* made of cut stone on the ground. The floor of the room 101 has stone flooring and wooded lath. There is a window on the west wall that has been closed by bonding. At the north end of the west wall, there is a niche that has a skylight window and there is also a circular planned niche on the north wall.

Since the necessary insulation was not provided in the flat roofs of rooms 101 and 102, which were made of earth during a time when the adobe was not regularly maintained, it is evident that the timber ceiling of room 101 has decayed and rotted, the mortar plaster on the floor of room 102 has flaked off due to dampness, and the cut stones have begun to erode and dissolve. To overcome these problems caused by the upper cover, after the plant cleaning on the roof is completed, straw will be laid on top of the rubble filling and the insulation material will then be laid on top of that and covered with pebbles, mud and earth.

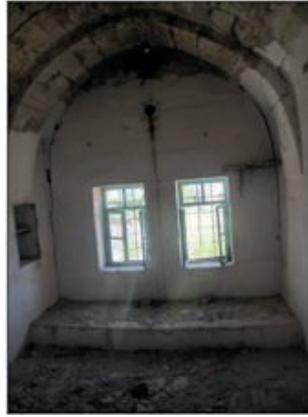
Photo 10. The North Wall of Room 102

Room 102 is made of cut stone and is located on the east side of the rooms on the upper elevation. The room is covered by a cradle vault extending along the north-south axis and supported by three arches. On the north wall of

the entrance door, there is a small window to the east of the door, and the room is illuminated by two rectangular windows on the south wall (Photo 10).

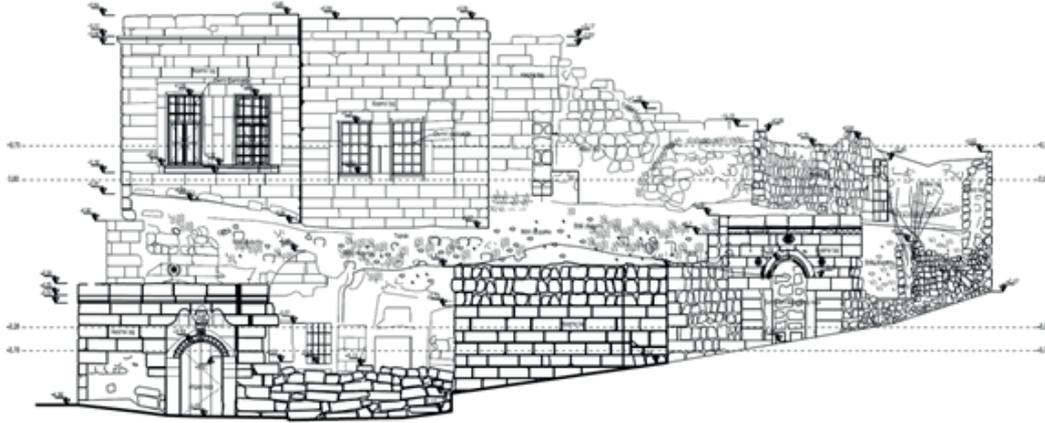
Figure 8. The south Facade of the Building

There were two rectangular windows on the southern facades of cut stone rooms located at the upper elevation. These windows were fitted with interlocked iron bars. While the western wall of the room was finished with a profiled moulding, the wall of the room on the east side was finished with a plain and simple moulding (Fig. 8).

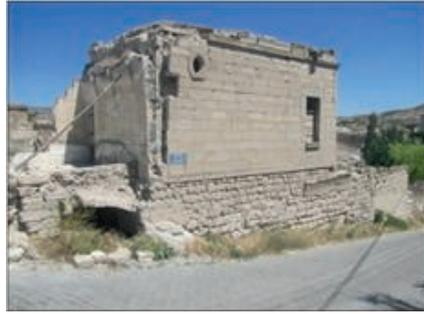
Photo 12. West Facade of the Building

goyle on the stone that catches one's attention. On the western front, stones that are arranged in four rows between the rubble stones. These

rows of stones are believed to have been the beginning of an arch (Photo 12).

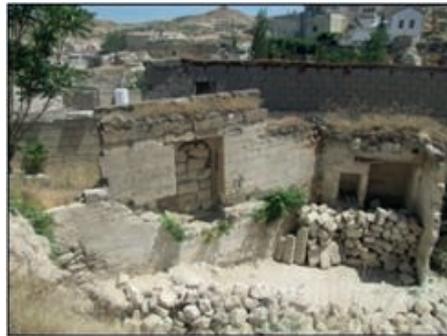
Photo 13. The View of the Building From the Upper Courtyard to the Lower Courtyard

gate to the courtyard was closed at a later time. The traces of the staircase leadings to the upper courtyard from the lower courtyard of the building is visible on the eastern courtyard wall (Photo 13), and there are three joist hanger arch stones and a niche on the eastern front of the room 102 (Photo 14).

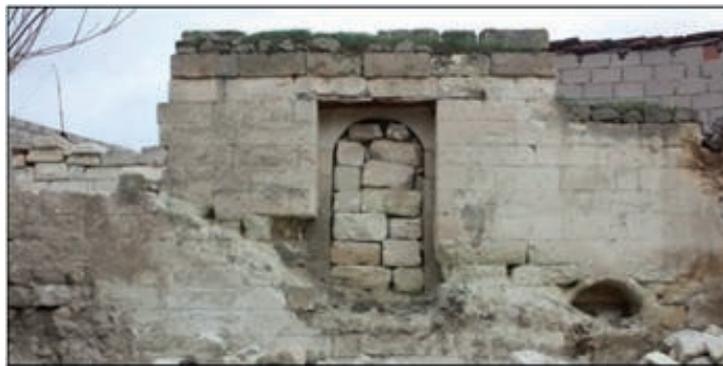
Photo 21. The Trace of the Stairs on the Courtyard Wall

It is evident from the traces that the lower courtyard and the upper courtyard are connected to one another by a staircase located on the southeast side of the lower courtyard.

It is further determined that the courtyard entrance door in this section opens to an intermediate landing of this staircase (Photo 21).
